GROUND FREEZING TO SUPPORT HISTORIC BUILDINGS WHILE TUNNELING BELOW

ABSTRACT

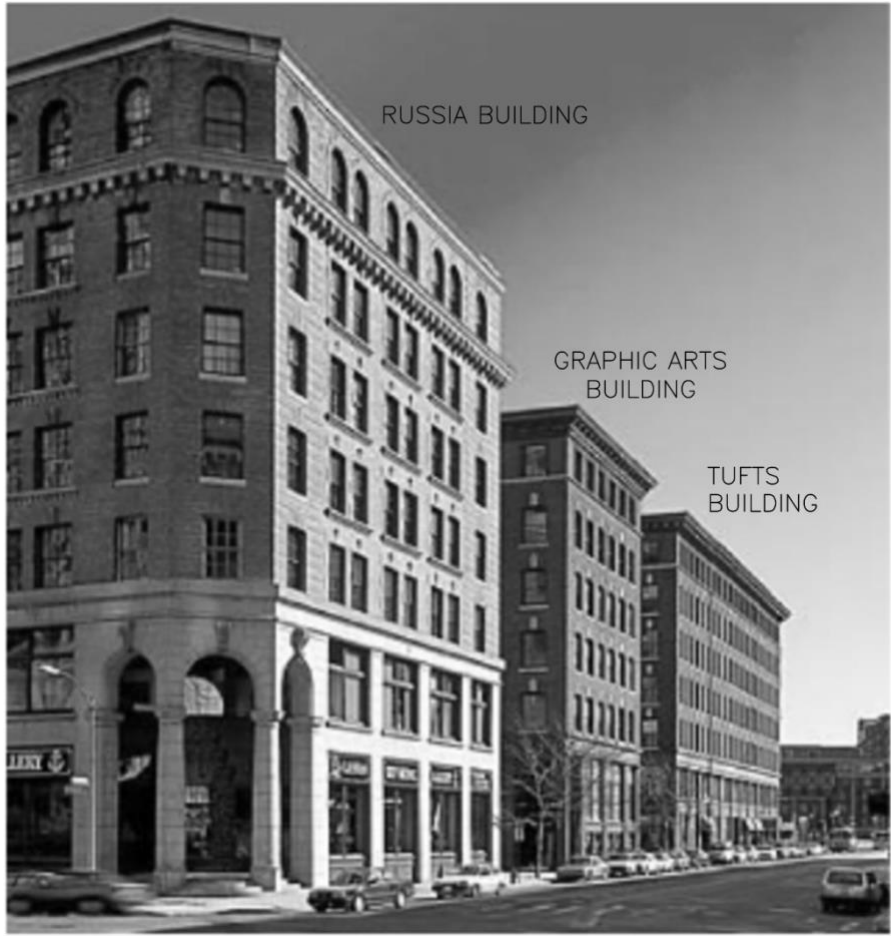
Figure 1. Russia Wharf Buildings, facing east.

The route selected for this light rail tunnel extended beneath the adjacent Fort Point Channel and below two historic five-story structures, the Russia Wharf and the Graphic Arts Buildings, supported on timber piles and immediately adjacent to a third building. The buildings are shown in Figure 1. The path of the tunnel is illustrated in Figure 2. The Program Manager was DMJM-Harris. The tunnel designer was Dr Sauer Corporation, who originally proposed the tunneling method, including using ground freezing beneath these buildings to stabilize the ground and to re-support the buildings on the tunnel lining using the stub ends of the original wood piles. Mueser Rutledge Consulting Engineers, PLLC were the frozen ground engineers and designers of the underpinning and building protections system. Details of the final construction plan were a collaboration between the engineers, the transit authority, the building owners, the general contractor, and the freezing subcontractor after the contract was awarded.
