Excavation along the Atlantic Seaboard, Cape Town – Part 2: Modern-Day Development

The following article is the second in a three-part series that reviews the historical, current and future practice of excavation along the Atlantic Seaboard in Cape Town and is the full version of an abridged paper that will be presented at the 2nd Southern African Geotechnical Conference in Umhlanga from 28 to 30 May 2025. **The first article** was published in the March 2025 issue (Vol.33, No.2) of *Civil Engineering*.

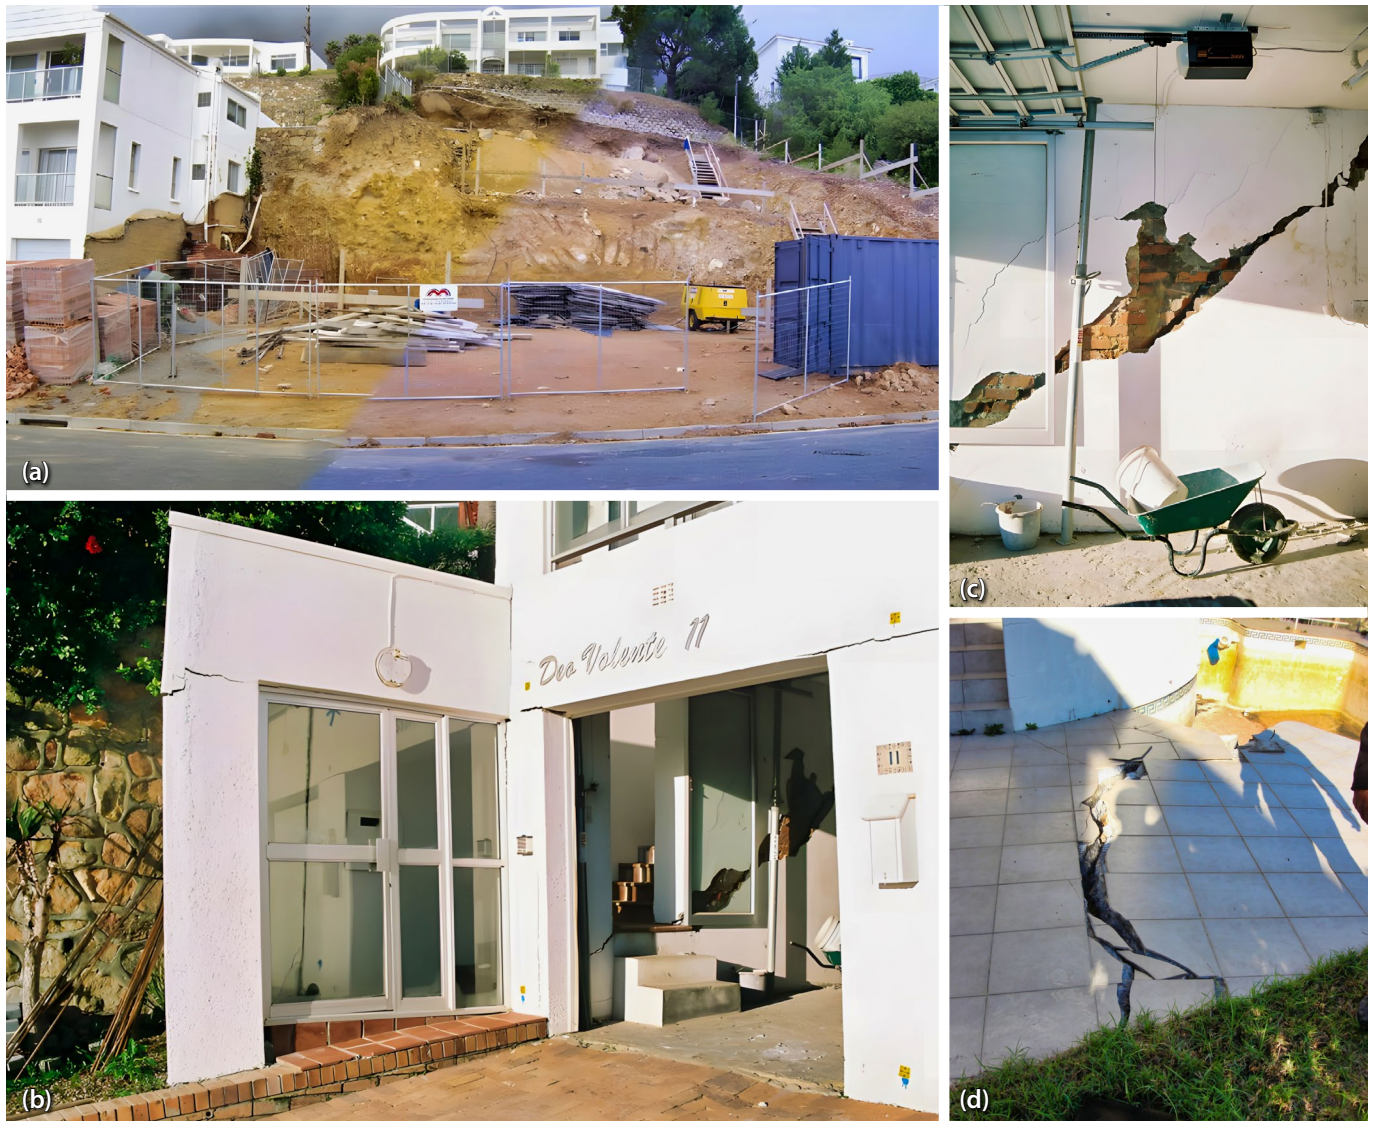
Figure 2 (a) Unsupported cut created in Barbara Road, Camps Bay, (b&c) damage to the adjacent house, and (d) damage to the house above the cut

There have been several instances where unsupported cuts have resulted in collapse or significant damage to neighbouring properties, with the failures at Dunmore Apartments and Barbara Road being the most notable. Photos of the Barbara Road slip (to the south in Figure 1) and the resulting damage to adjacent properties are shown in Figure 2. This unsupported cut led to damage to four adjacent properties and years of legal disputes.

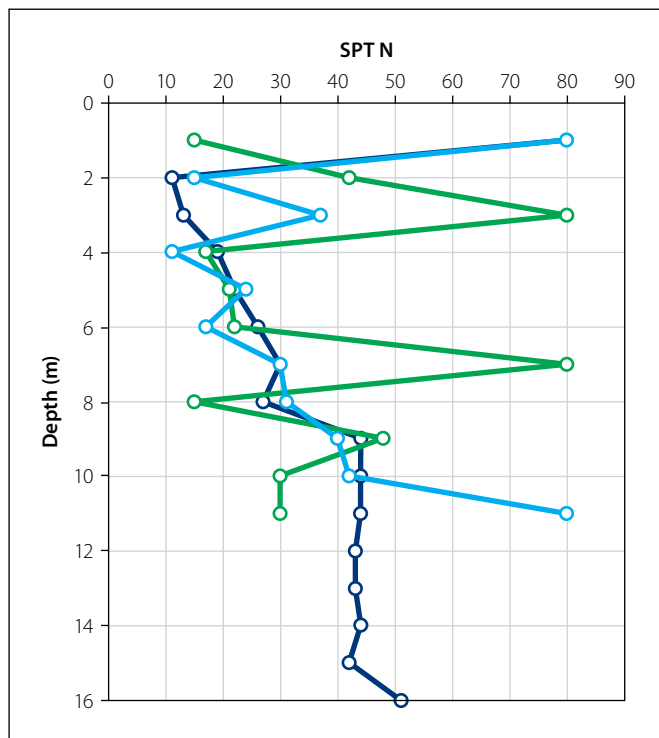
Figure 3 SPT-N plots for Boulder apartment

The site is situated in colluvium overlying residual granite, with the depth of the colluvium increasing and larger boulders present towards the south, within the drainage gully. The SPT-N plots are shown in Figure 3. The water table was located just above the residual granite.

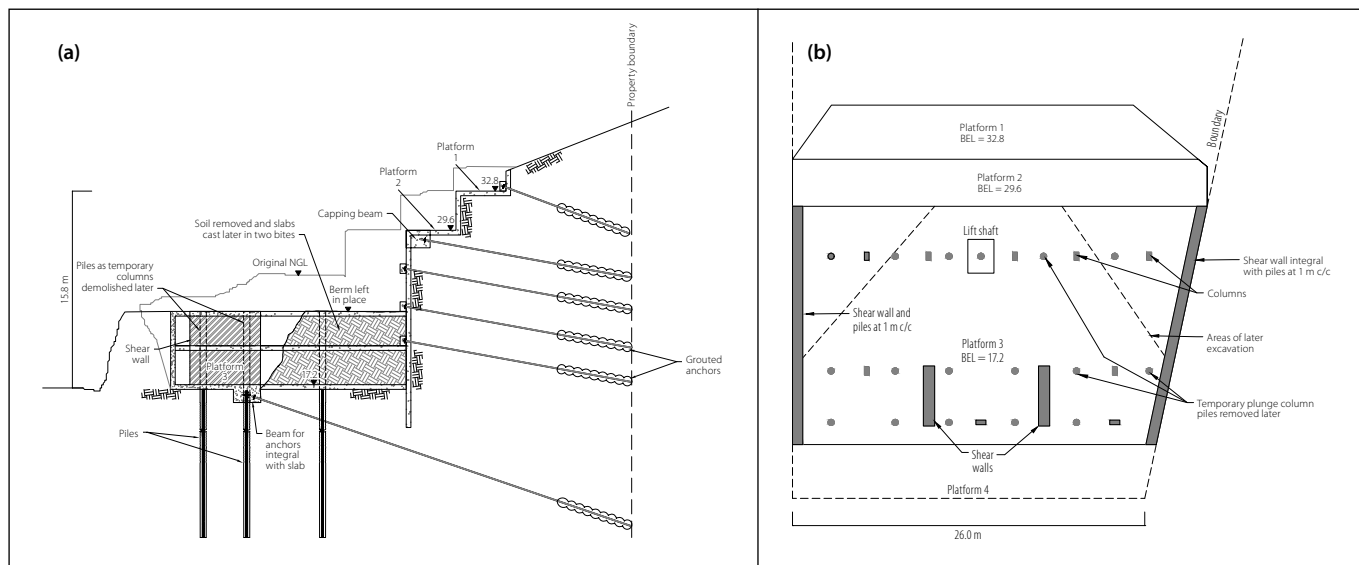
Figure 4 (left) Cross section through lateral support system at Boulder apartments and (right) plan view showing location of shear walls and plunge columns

An overall cut of 17 m was required for the construction of a seven-level apartment block in Bali Bay, Camps Bay (Site 10). The excavation included a 12 m vertical face, along with two shallower vertical cuts above. The site is located next to an old, infilled drainage gully to the south. No grouted anchors were allowed to be installed into the neighbouring properties and shear walls had to be minimised to preserve architectural freedom. As a result, the rear lateral support line was shifted 22 m into the site to ensure that permanent grouted anchors could be installed within the property boundary (see Figure 4)

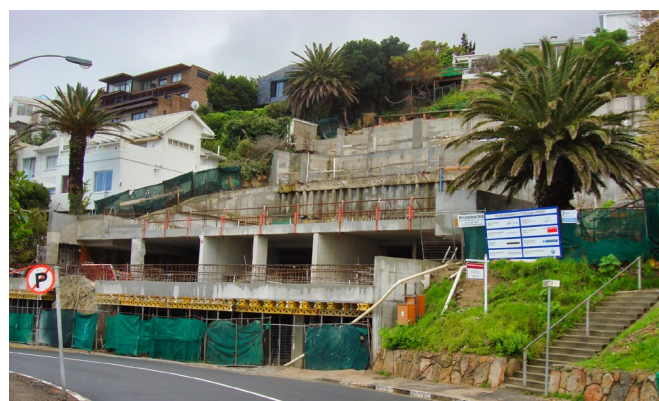
Figure 5 Lateral support at Boulder apartments

Figure 5 provides a photo of the near completed lateral support system.

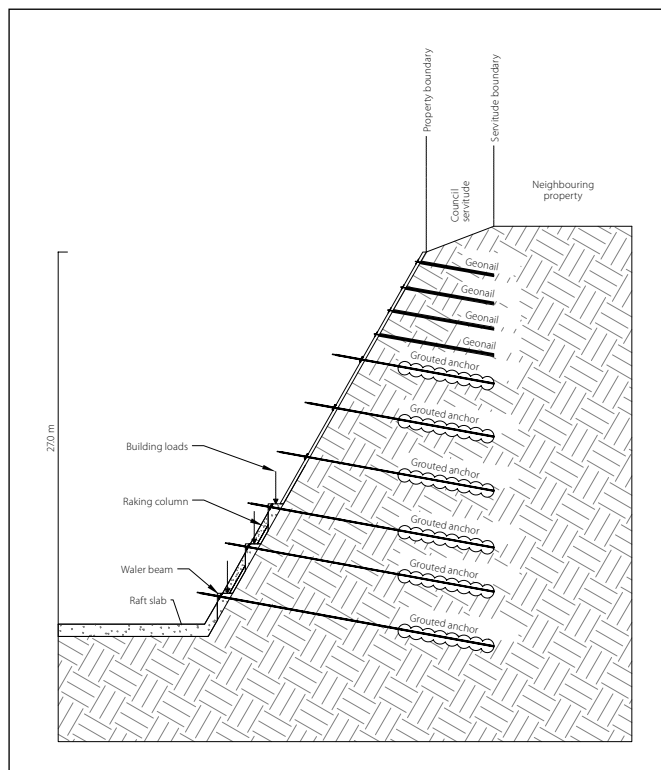
Figure 6 Cross section through 60° lateral support

The design incorporated a nailed shotcrete facing interspersed with walers with permanent grouted anchors. On the eastern and northern faces, the lateral support was battered at a 60° angle from the horizontal, starting from the property boundary (Figure 6). This resulted in the lateral support toe line stepping into the site at an angle, nonparallel to the boundary. The reinforced concrete frame that partially rested on the southern and northern faces was supported by waler beams connected to raking columns and a concrete raft foundation.

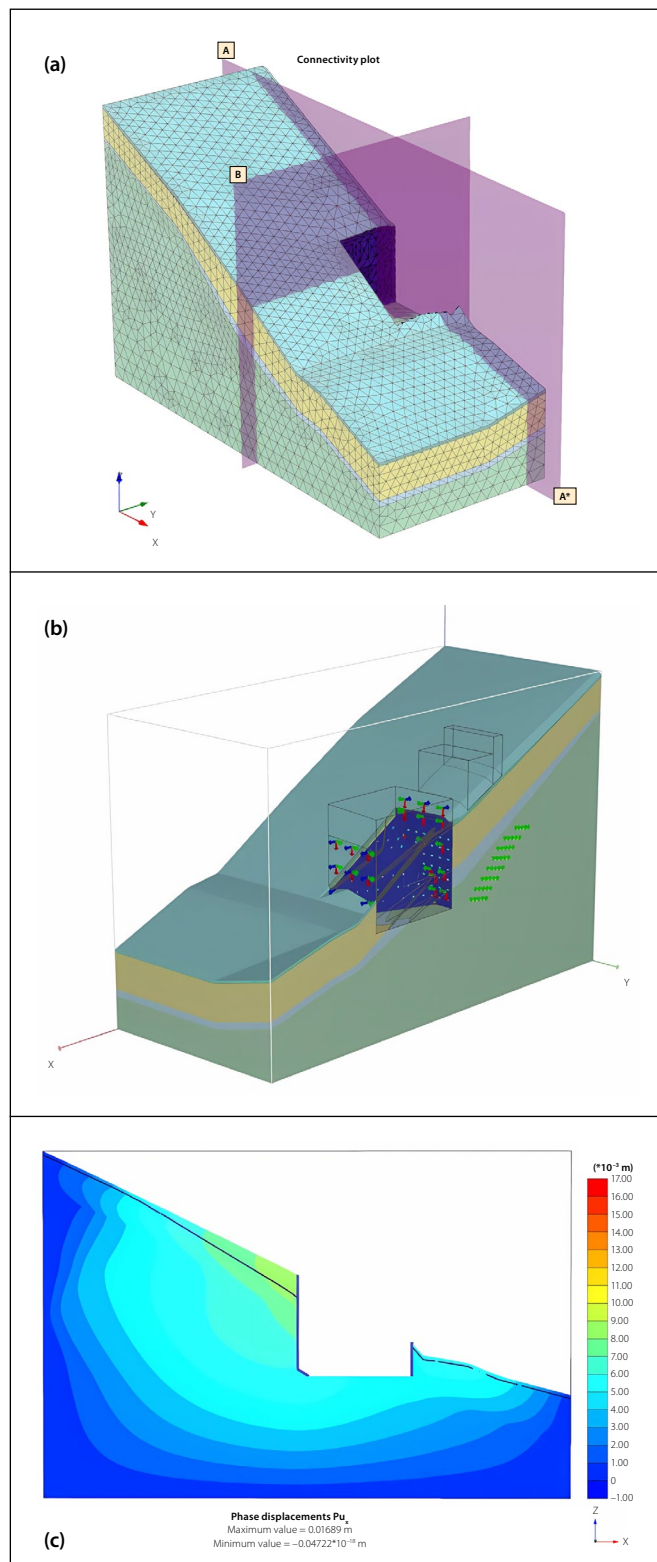
Figure 7 (a&b) 3D finite element model and (c) displacement plot through an east-west section

Additionally, a 3D FE analysis was conducted (Figure 7), which predicted a total displacement of 20 mm after excavation. This displacement is lower than the 32 mm predicted by the 2D analysis. This difference can be attributed to the more accurate representation of the failure mechanism in the 3D model, where additional strength from the sides of the slip surface is considered. Furthermore, in some cases, if the soil was able to arch between the two lateral support faces, the pressure could be further reduced, as the failure mechanism would resemble that of a semi-silo.

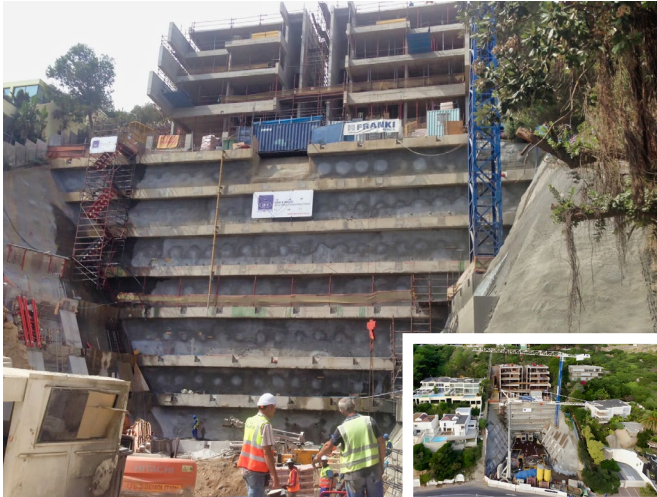
Figure 8 Photo of Clifton Terraces excavation

As the anchors are permanent, thorough quality assurance and control processes were enforced to ensure double corrosion protection was achieved at the grouted anchor heads, where the anchors are most often prone to corrosion, especially if a void is left in the drilled hole just behind the face. Some grouted anchors were installed with removable covers for future inspection and lift-off tests as part of the maintenance plan. Ground movement measurements were undertaken along with accurate survey readings. The final total displacement measured, after construction of the building on the lower 26 m high eastern face, was 41 mm, which aligns well with that predicted from the Hoek-Brown 2D analysis. A photo of the lower tier excavation is provided in Figure 8.

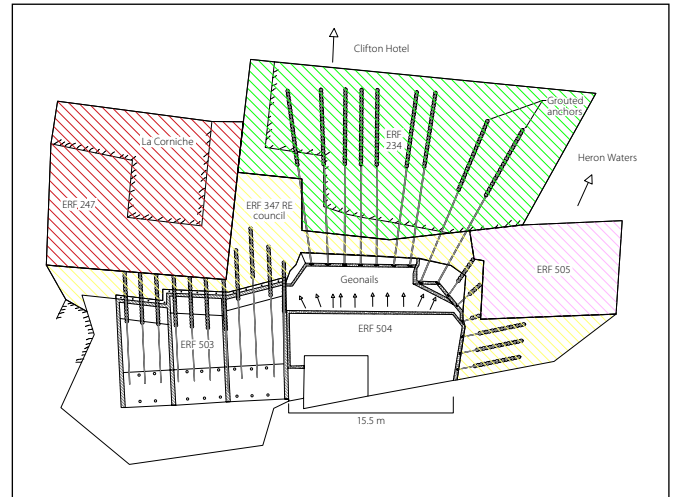
Figure 10 Plan view of anchor layout required for ERF 503 and 504

Permission was obtained for permanent anchors beneath the Clifton Hotel and public open space but not beneath La Corniche and Heron Waters (erven 247 and 237). This required innovative solutions. The complexity of these is illustrated by Figure 10 and 12, showing the spread of anchors in the area.

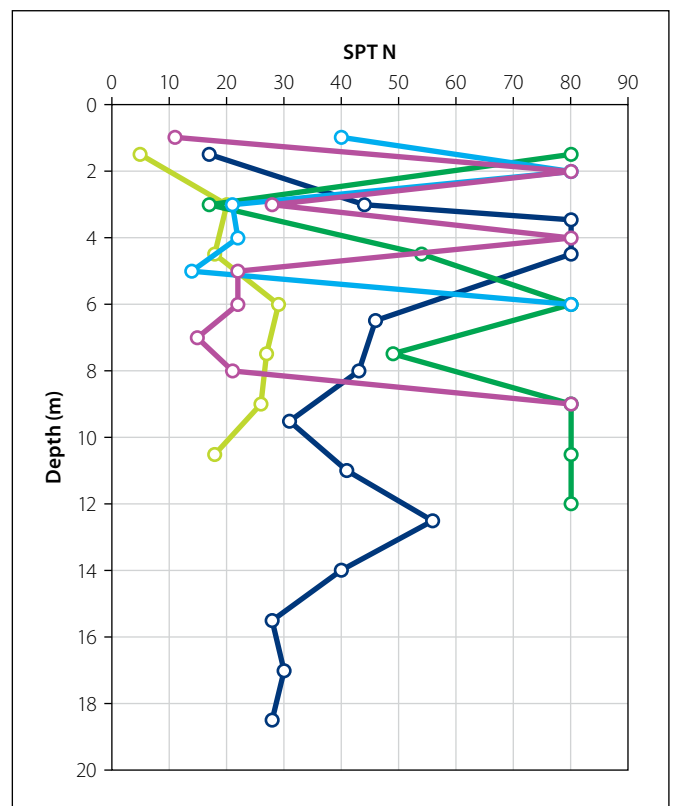
Figure 11 SPT-N plots at ERF 234 and 503

The site is predominately situated on a promontory of mixed landslide debris and colluvium underlain by granite bedrock at depths in excess of 19 m. Evidence of the landslide is provided by aerial photography extending to the top of Lion's Head and the mixture of very large granite and sandstone boulders exposed on the beach. The SPT-N plot is provided in Figure 11.

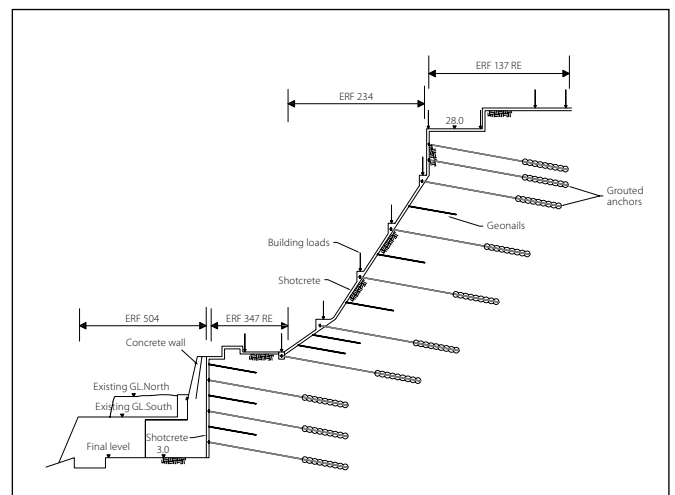
Figure 12 Section through ERF504 and 234

As a result, a battered lateral support system was chosen, with a face angle ranging from 30° to 50°. This solution, however, presented another challenge: the building needed to be founded on foundation pads or walers resting on the lateral support system. While the in-situ colluvium offered sufficient bearing capacity, the vertical load's downslope driving component had to be counteracted by stressed grouted anchors, which provided a resulting additional frictional force to balance the load (see Figure 12 and 15).

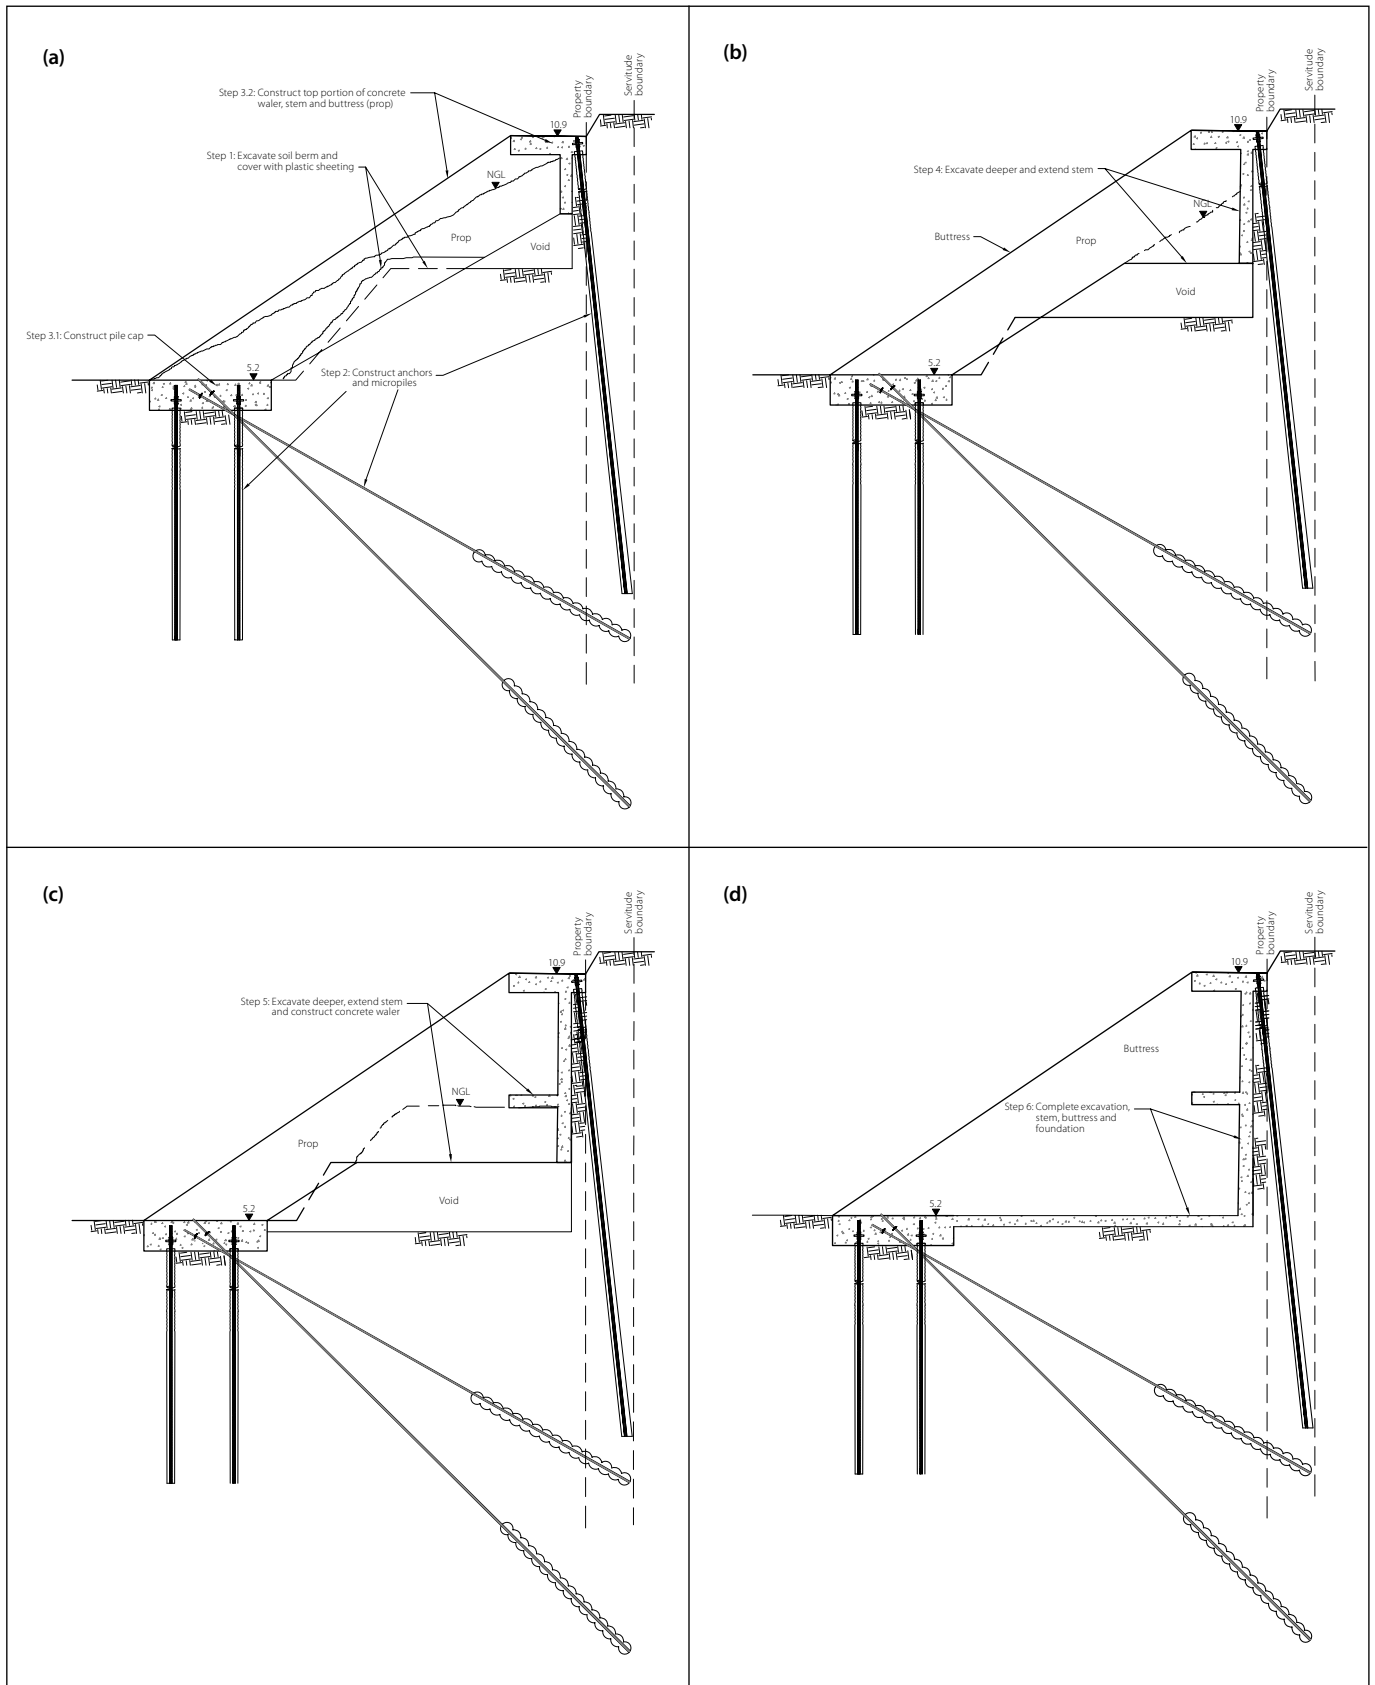
Figure 13 Construction sequence of buttress lateral support on ERF503

On ERF 503, a buttressed approach was implemented, with the excavation, buttresses, and waler constructed in a stepped sequence from the top down. Before the retaining structure was built, a narrow raft foundation, reinforced with micropiles and anchors, was installed at the toe of the buttresses. Openings in the buttresses were later created to facilitate access between rooms (see Figures 13 and 14).

The construction of the apartment on ERF234 began around 2006, followed by the commencement of construction on ERF503 around 2010 and thereafter ERF504. A photograph of the nearly completed buttressed lateral support is shown in Figure 13, while the lateral support on ERF234 is shown in Figure 14.

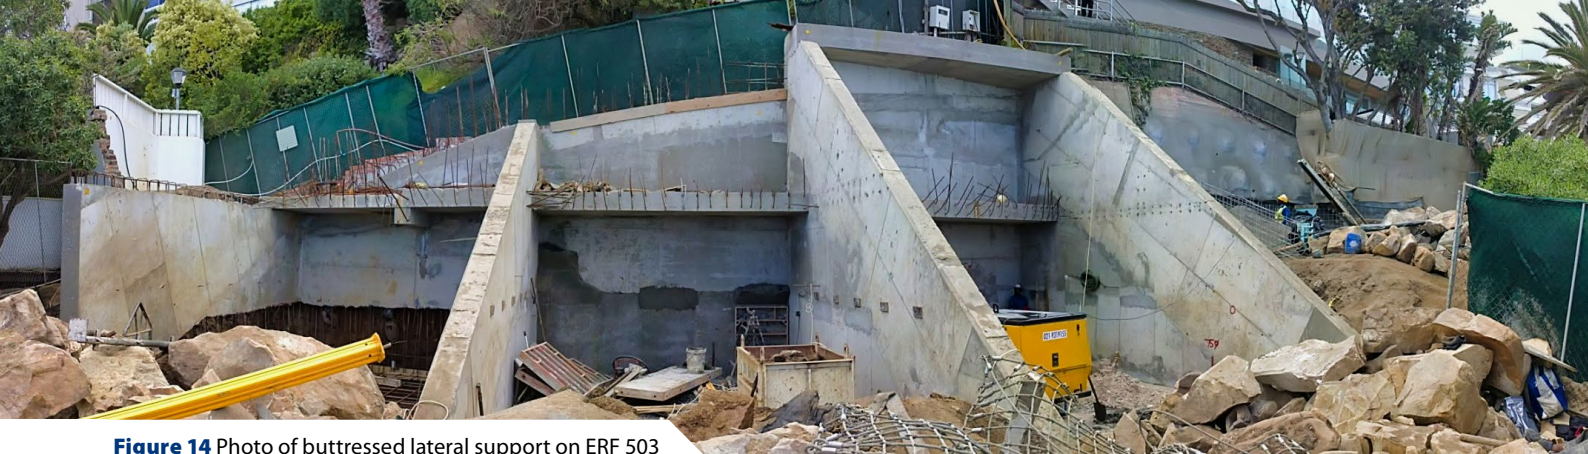
Figure 14 Photo of buttressed lateral support on ERF 503

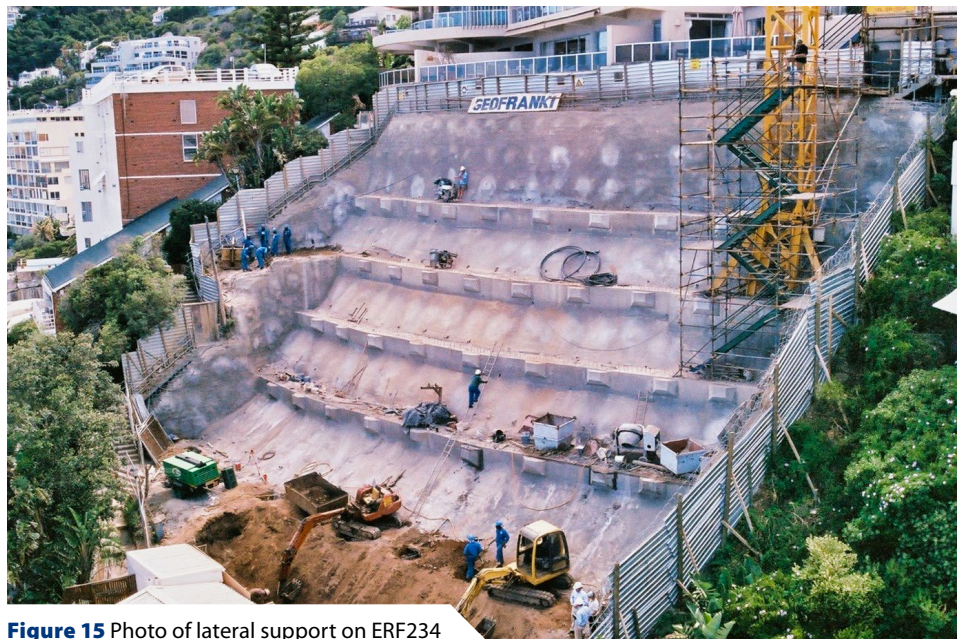
Figure 15 Photo of lateral support on ERF234
